# **HYDROGEOMORPHIC EVALUATION OF ECOSYSTEM RESTORATION AND MANAGEMENT OPTIONS FOR BACA NATIONAL WILDLIFE REFUGE**

**Greenbrier Wetland Services  
Report 13-08**

**Mickey E. Heitmeyer  
Cary M. Aloia**

**October 2013**

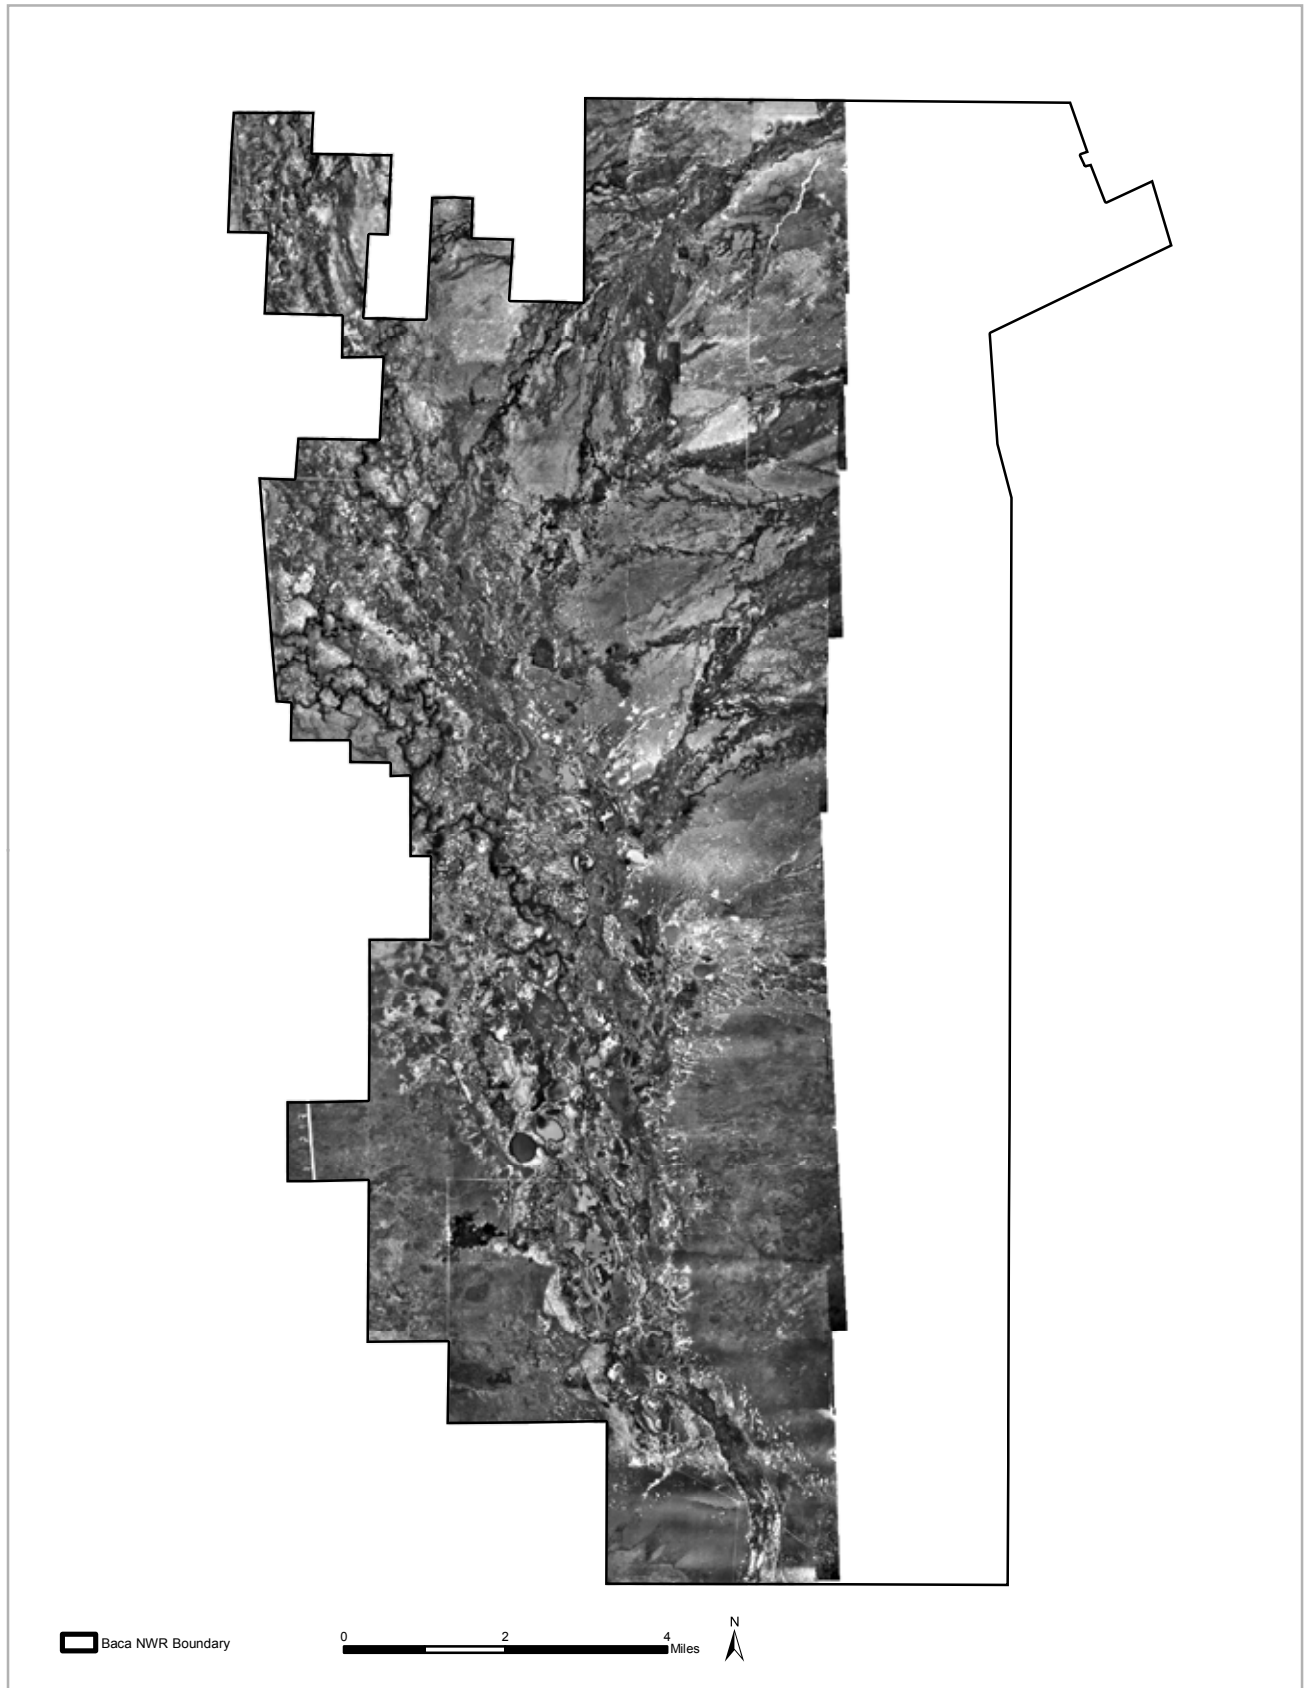
Figure 6. 1941 aerial photo of Baca National Wildlife Refuge.

subsequent sediments that are transported by wind. Wind deflation of the sabkha and eolian sand sheet has created temporary or playa lakes throughout the western and southern portions of the refuge (seen in the partial 1941 aerial photo, Fig. 6) and in the dune fields. Many types of dunes have been created as a result of the wind deflation of the sump area (Madole et al. 2008).

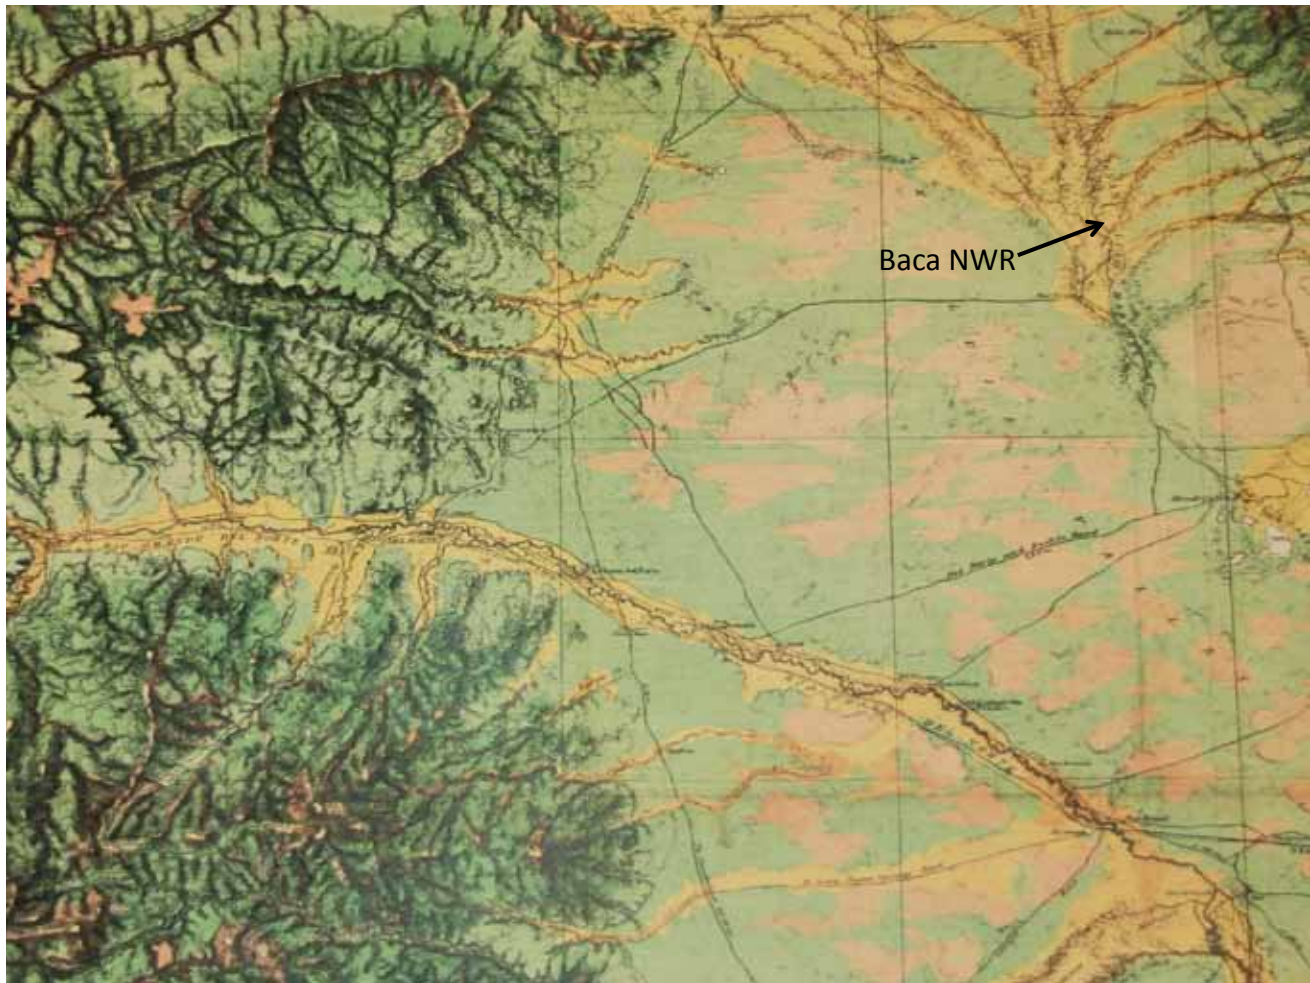
Figure 20. Wheeler Geologic Map of the San Luis Valley depicting land coverages. Yellow= Agricultural (irrigated); Pink= Arid and barren; Light green= Grazing; and Dark green= Timber. From U.S. Geological Surveys West of the 100th Meridian Land Classification Map of Southwestern Colorado: Expeditions of 1873, 74, 75, and 76. Atlas Sheet No. 61 (USFWS files).

The numerous historical creek corridors converging on the Baca NWR included active and relict stream channels and their floodplains. Remnant creek channel depressions are present throughout the refuge and these wetlands contain diverse communities of sedges, rushes, and grasses along with some annual plants such as goosefoot (*Chenopodium* spp.) and smartweed (*Polygonum* spp.) (Ramaley 1929, 1942; Carsey et al. 2003). Aerial photos from 1941 and recent aerial photos (Figs. 6, 19) show some water present in these wetlands throughout the summer at least during wet years within old lake basins. This information coupled with botanic inventories conducted by Ramaley (1929, 1942) indicate that semipermanent flooding regimes were historically present in some years in at least the larger deeper “distinct” playa basins present in the Upper Sump area. Gunnison’s Expedition recorded relatively large marshes in the Baca NWR area that made travel difficult from east to west making it necessary to travel along the eastern edge of the SLV north of the town of Crestone before going west (Unknown 1970). A map of Wheeler’s Expedition in the late-1800s indicates that herbaceous wetlands and irrigated land were the dominant habitats along creeks on Baca NWR (Fig. 20).

GLO surveys and historical accounts indicate that eastern portions of the alluvial fans of what is now Baca NWR historically were covered by salt desert shrub and by large expanses of grassland (Fig. 5, 20; Unknown 1970). As previously mentioned, the exact historical composition of upland shrublands is uncertain, but current shrublands have increased amounts of greasewood and/or rabbitbrush and former grasslands now have a higher composition of shrubs, especially greasewood (noted as transition habitat in Fig. 28) or have been converted to different types of wetlands. A variety of factors including haying, grazing, and changes in hydrologic regime apparently have caused these habitat changes through increased soil temperature and salinity to name a few. Changes in soil temperature and salinity stress individual plant species differently throughout the growing and dormant seasons depending upon their physiology and growth characteristics (e.g., see Sayre 2001).

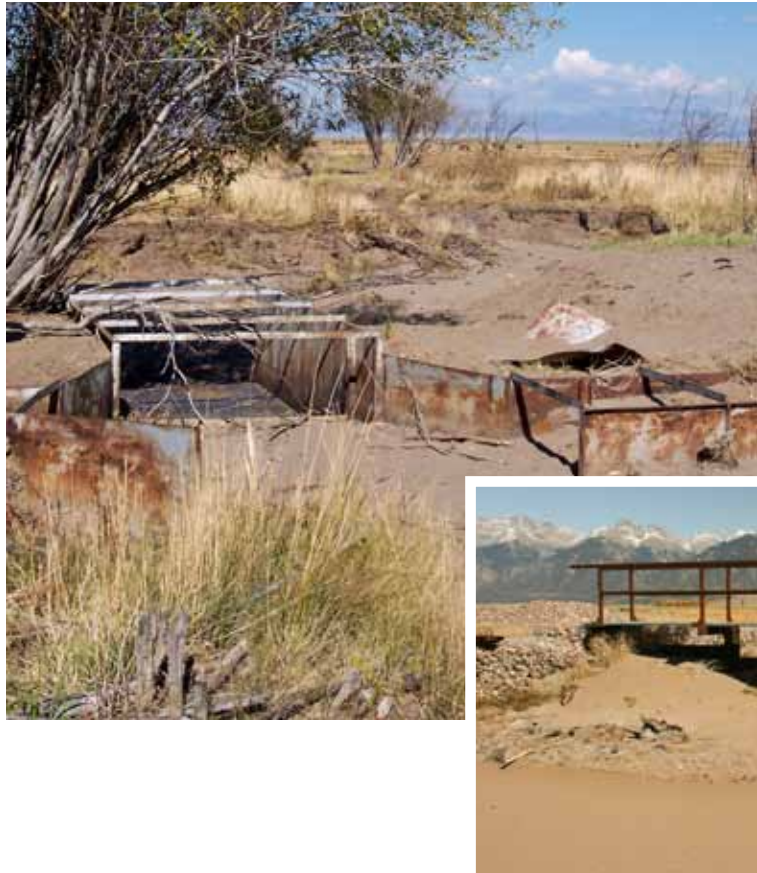
Figure 33. Photos of structures located within sand channels that have impeded flow, cause sediment deposition, and created artificial nick points in creek channels on Baca National Wildlife Refuge.

of water to designated areas, many water-control structures are inactive or actually impede water flow (Figs. 24, 25). Many of these ditches and water-control structures are present throughout the San Luis Creek drainage and along Crestone, Cottonwood, and Deadman Creeks. Structures located within or immediately adjacent to creek channels have caused incision of channels throughout Baca NWR and also have re-routed some creek channels around the structure if sediment has built up behind or in it (Figs. 33a,b). Future water resources at Baca NWR, both surface and groundwater, may become more limited as unconfined and confined aquifer levels decrease, alluvial water tables decline, and climate changes cause extended drought conditions in the future. Further reductions in groundwater availability may require that water management on Baca NWR will need to prioritize water delivery to meet top priority objectives. Management of water flows through natural creek channels would reduce time, labor, and potentially costs of maintaining certain ditches, levees, and water-control structures, which require annual repair. Some water-control structures are placed outside of natural drainage patterns, set at wrong invert elevations, lack the capacity to meet the needs of flows through the system, or are in locations where soils inhibit the long-term sustainability of the structure (e.g., structures placed in sand channels) (Figs. 33a,b). Bed levels of creek channels that have become incised should be restored to allow for greater bank storage which historically helped to maintain a higher water table in adjacent grasslands and wet meadows (see Zeedyk and Clothier 2009).

Any potential restoration activities that incorporate new development of water delivery infrastructure should be approached with caution because the Baca NWR represents an ecosystem that is more intact than most others in the San Luis Valley. Further expansion of the current water-control infrastructure runs the risk of altering historical conditions even more. Some replacement or modification of existing water-control structures may be necessary to help restore natural drainage

pathways but should be done in such a way that the structures increase the capacity of the current system to mimic the historical functioning of the area rather than increase or expand the extent of artificial water use across the alluvial fan and floodplains of the site. Specifically, construction or replacement of water-control structures in areas with sandy soils is not desirable.
